UNDERWATER BRIDGE INSPECTION REPORT

STRUCTURE NO. 57501
CSAH NO. 22
OVER THE
RED LAKE RIVER
DISTRICT 2 - PENNINGTON COUNTY

PREPARED FOR THE
MINNESOTA DEPARTMENT OF TRANSPORTATION
BY
COLLINS ENGINEERS, INC.
JOB NO. 5221 (CEI 162)

MINNESOTA DEPARTMENT OF TRANSPORTATION
UNDERWATER BRIDGE INSPECTION

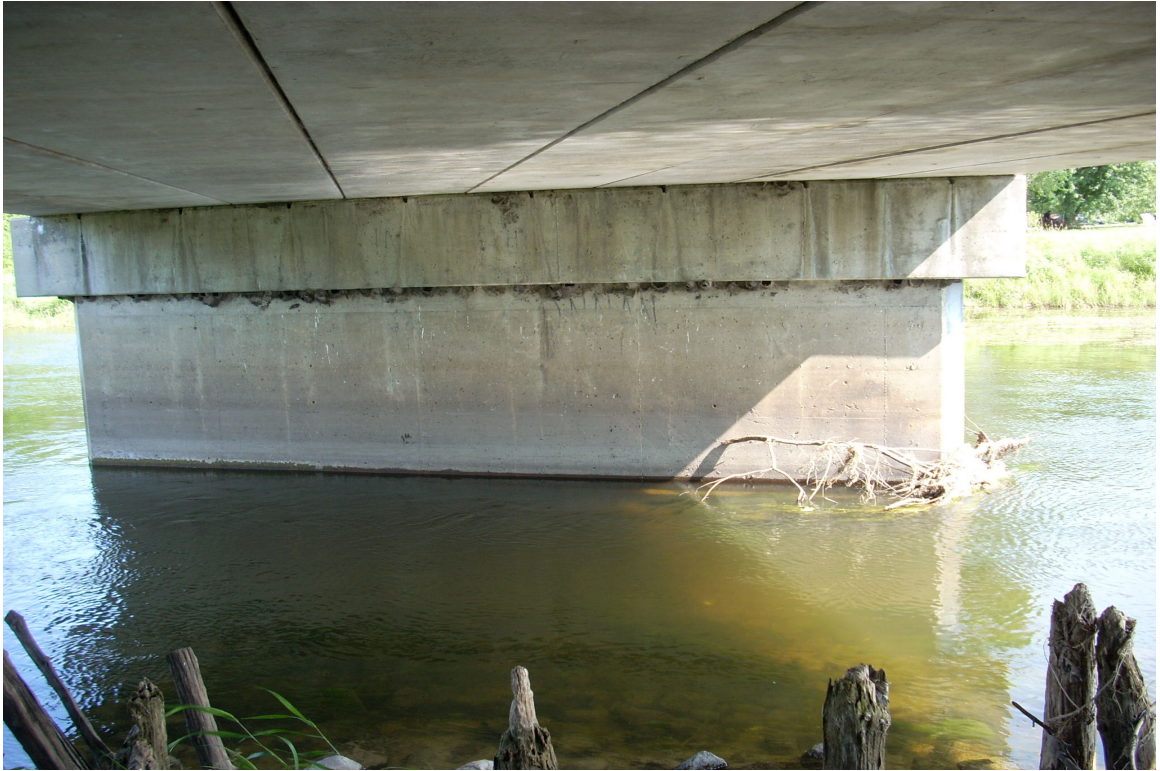
- (B) A light to moderate accumulation of organics and/or timber debris was observed from the waterline to the channel bottom at the upstream end of Pier 1.

Photograph 1. View of Pier 1, Looking North.

- A light to moderate accumulation of vegetation and organics with 6 inch diameter timber debris was observed from 1 foot above the waterline to the channel bottom and radiating 5 feet from the upstream nose of Pier 1.

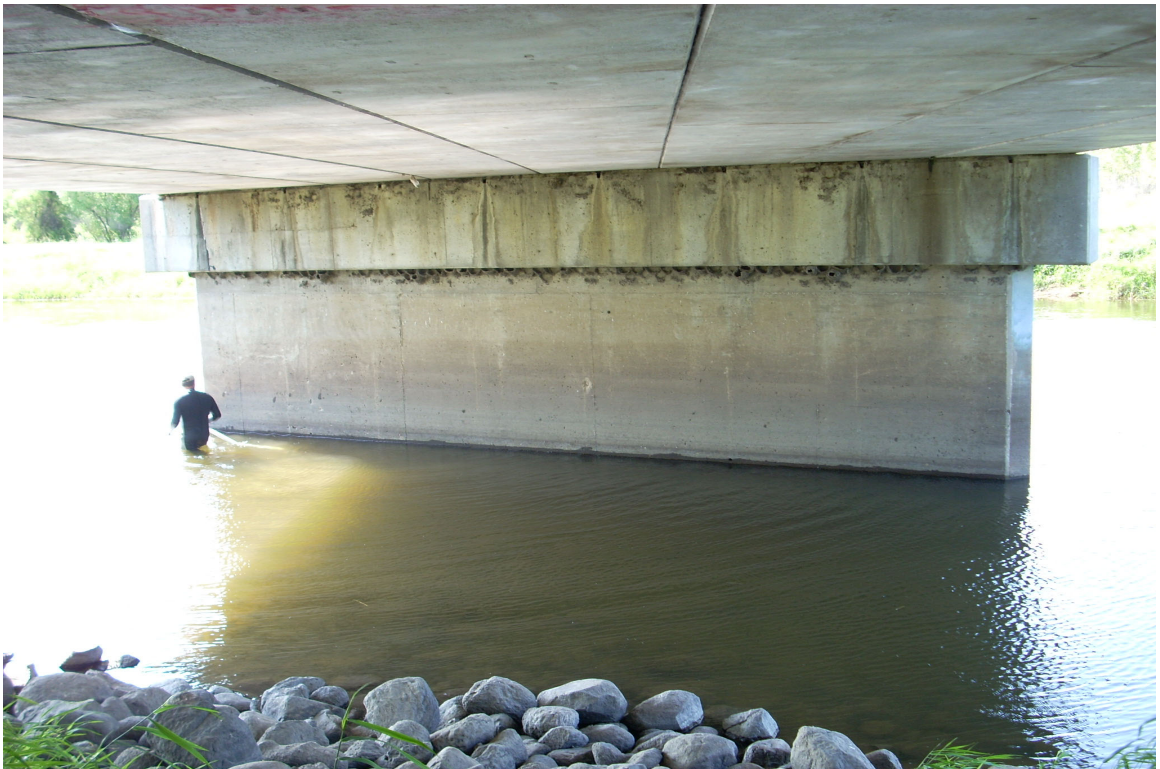
Photograph 2. View of Pier 2, Looking South.

- The bottom portion (stepout) of the concrete shaft was exposed around the entire shaft of Pier 2 with up to full height (1 foot) vertical exposure from the upstream 1/4 point of the south face, around upstream nose to the upstream 1/4 point on the north face. Undermining was observed in the location of full height vertical exposure with a maximum of 0.8 foot height at the upstream nose. The east one ward most steel H-Pile was exposed in the area of undermining with light surface corrosion.

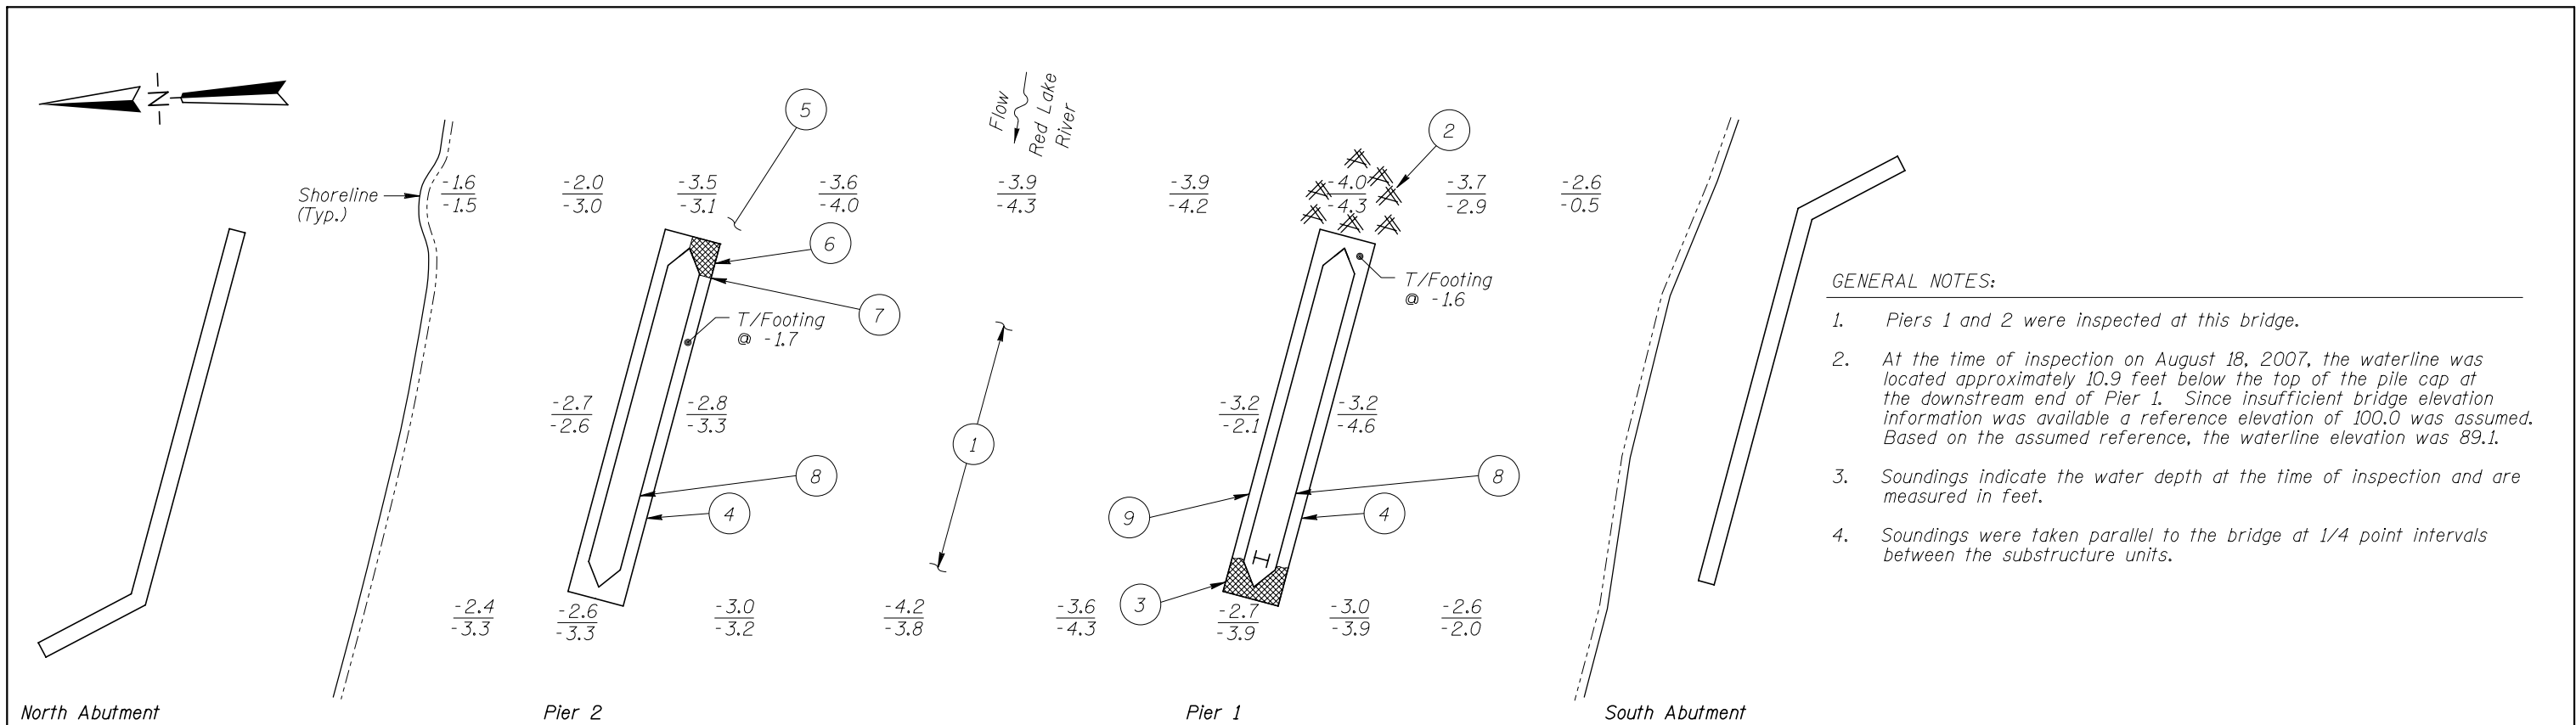
INSPECTION AND SOUNDING PLAN

- The channel bottom material consisted of silty sand and gravel with scattered 6 to 8 inch diameter cobbles and up to 3 inches of probe rod penetration.

- The bottom portion of the shaft (stepout) was broken off at the downstream end of Pier 1 exposing three corroded horizontal steel reinforcing bars. The broken piece of the step was lying on the channel bottom and was approximately 3 feet long (E/W).

- The concrete of the bottom portion of the shaft (stepout) at Piers 1 and 2 was frequently soft on the surface with random irregularities and section losses having up to 5 inches of penetration.

- Riprap was observed on the channel bottom measuring 1 to 2 feet in diameter at the upstream nose of Pier 2.
- The shaft bottom step of Pier 2 was cracked and detached at the south eastern corner of Pier 2 with an approximate length of 2.5 feet (E/W) and an approximate width of 8 inches (N/S).

- The concrete of the pier cap and shaft for Pier 1 and 2 were typically smooth and sound with random minor areas of poor consolidation with 1/4 inch maximum penetration and with minor vertical hairline to 1/16 inch wide cracks extending from top pier cap to bottom of lower pier shaft step.

- The bottom portion (stepout) of concrete shaft was exposed around the entire shaft of Pier 1 with up to full height (1 foot) vertical exposure around the entire pier. Undermining was observed in the location of full height vertical exposure with a maximum of 1.4 feet height at the upstream nose. All of the H-Piles were exposed in the area of undermining with light surface corrosion.

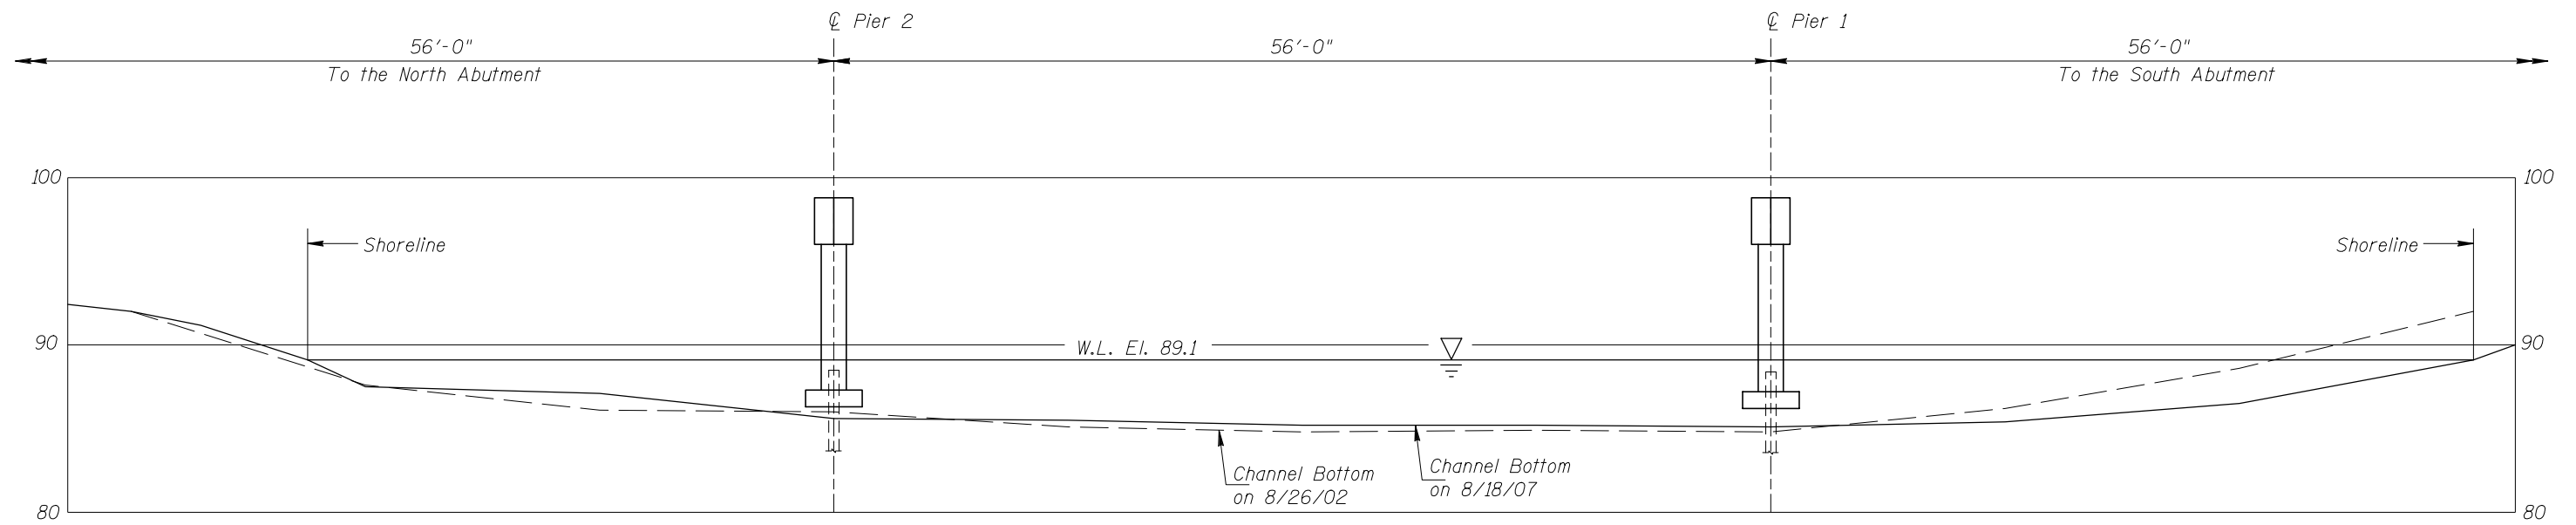
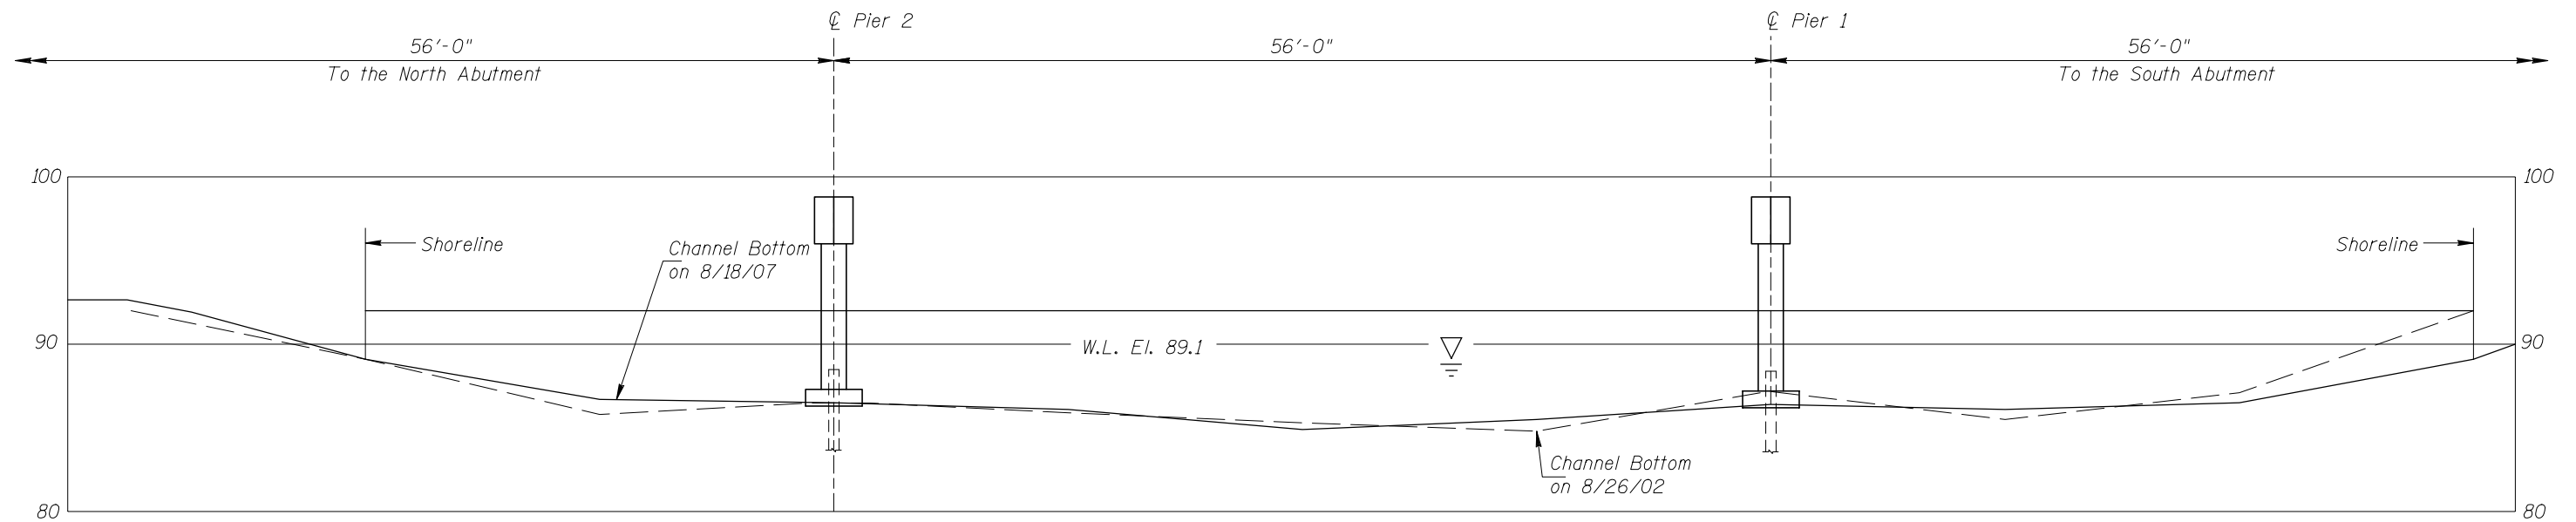
- (A) No design drawings were provided and it is assumed that the piers consist of a steel H-pile bent encased in concrete. The bottom of the encasement exhibited undermining exposing the easternmost steel H-piles at the upstream end of both piers with light surface corrosion. There was vertical face exposure of the footing (base of shaft step out at both piers) around entire perimeter of both piers, with 12 inches (full height) exposure around the upstream nose where the pile exposure was present.

- (A) The extent of undermining and foundation pile exposure has been reduced since the last inspection, so based on the present state of things and the scour stable (low risk) rating for the bridge, it is only recommended that future inspections particularly monitor the undermining and pile exposure.
- (B) Reinspect the submerged substructure units at the normal maximum recommended (NBIS) interval of five (5) years.
